# AVINOR NORWAY

AIP SUP  
50/2025  
29 AUG 2025

## ENAN - RWY, TWY and apron usage restrictions due to surface damage

Replaces AIP SUP 39/2025, changes: TWY B3 and B4

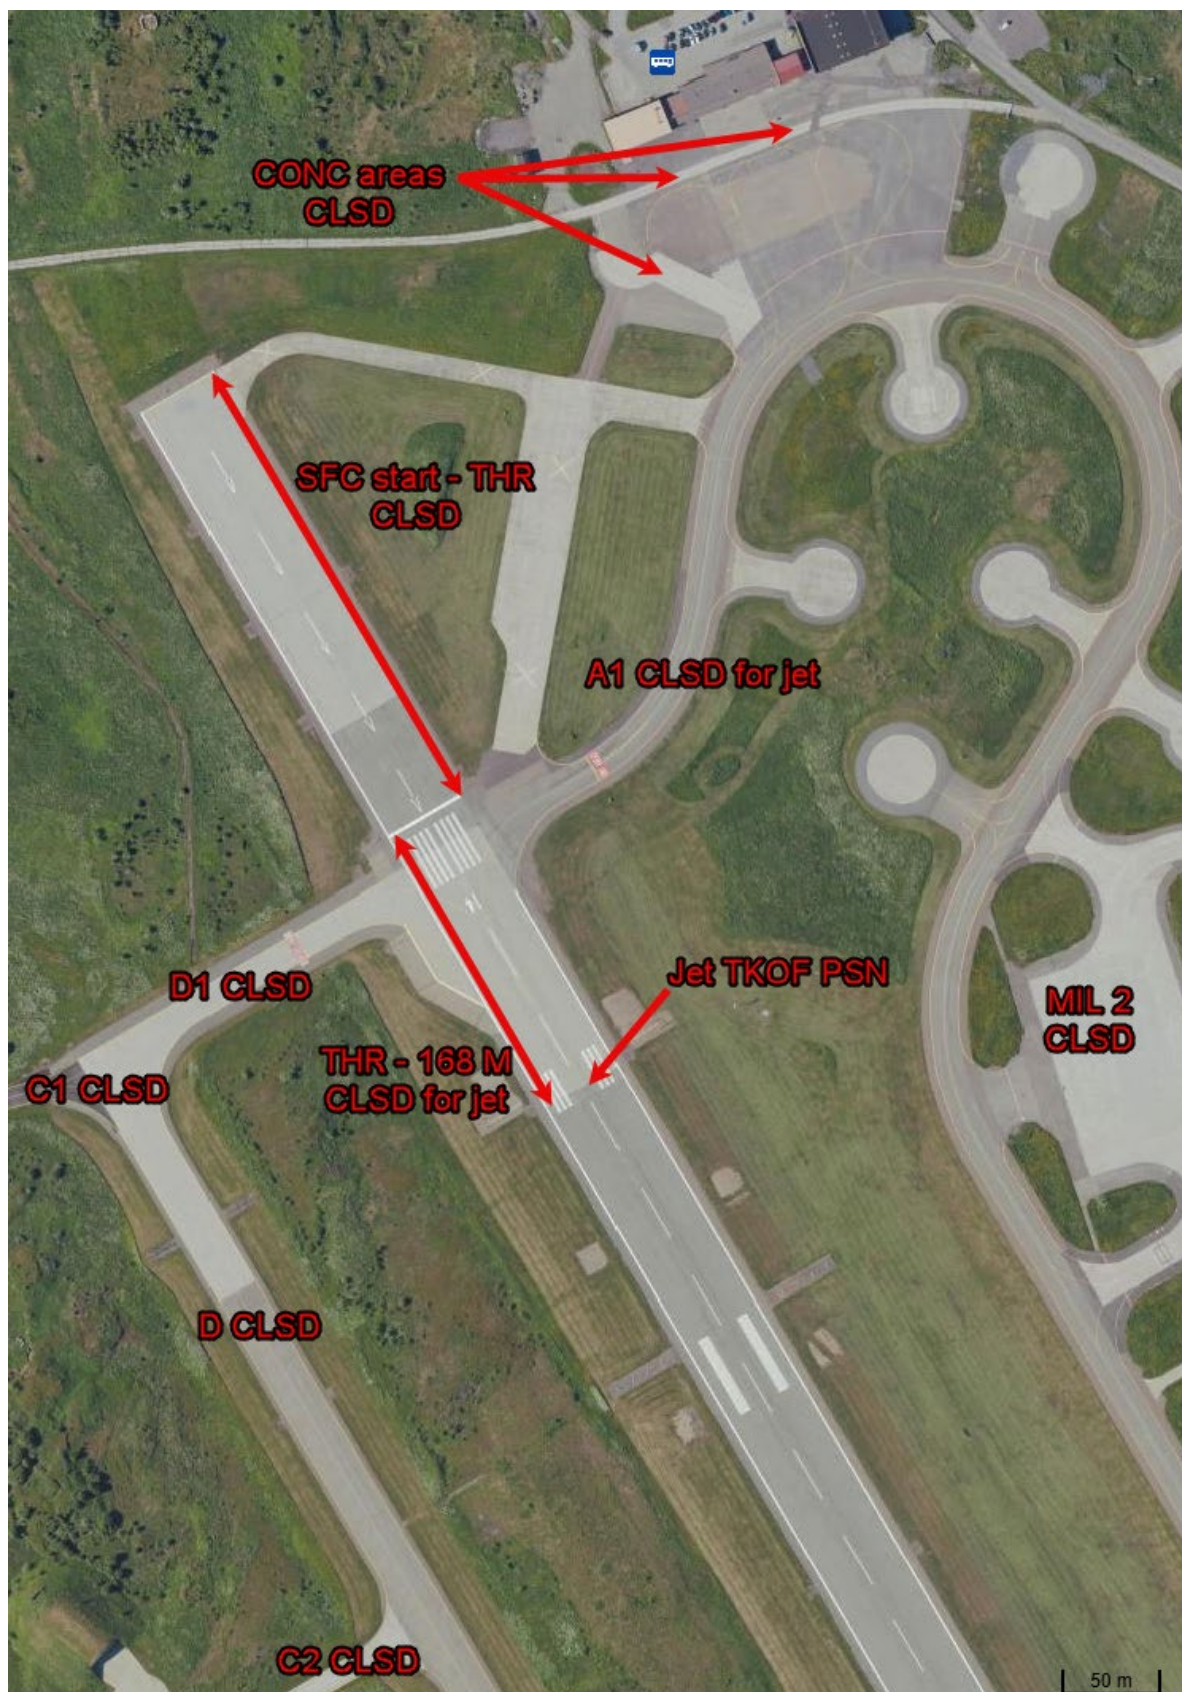
RWY 14

Due to surface damage, the first 168 M from THR 14 and the first 161 M from THR 32 are not suitable for taxiing and departure for jet engine aircraft.

Jet engine aircraft must be towed between the runway and the apron. This shall be coordinated beforehand with Widerøe Ground Handling station Andenes via e-mail [andenes@wideroe.no](mailto:andenes@wideroe.no). Arriving jet engine aircraft shall stop and shut down engines before the closed concrete surface by THR 14 to be towed via TWY A1. Departing jet engine aircraft will be towed via TWY A1 onto the runway and clear of the closed concrete surface by THR 14. Engine start may be expected after towing is complete.
